# ***ROCK-SOLID Inspections***

Home Inspection Services

123 S. Main Street Chicago IL 60000

Inspection Date: 2-28-2006 Time: 4:30pm

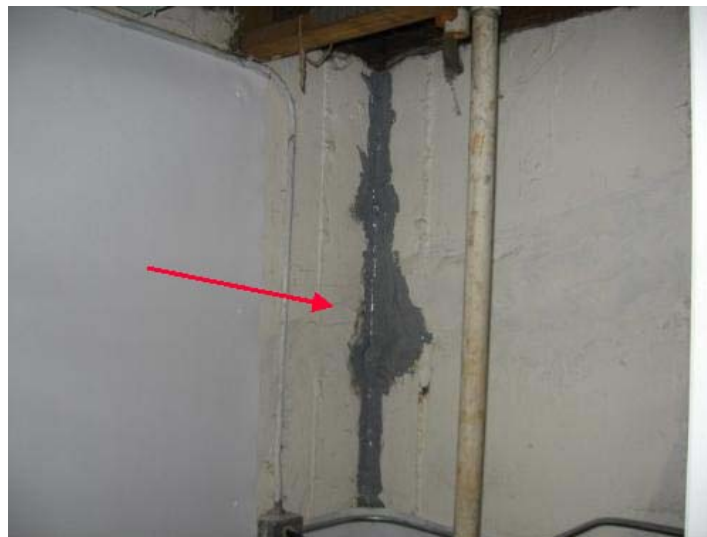
Type: Poured Concrete  
 Observations: Previous foundation repair noted.

Previous foundation repairs noted

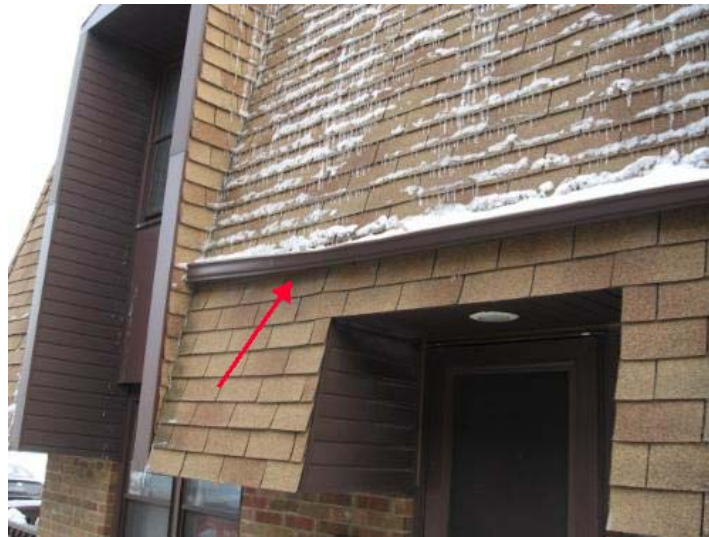
Materials: Aluminum  
 Observations: **Gutter over entryway is bowed, may allow water spillage.**

Bowed gutter

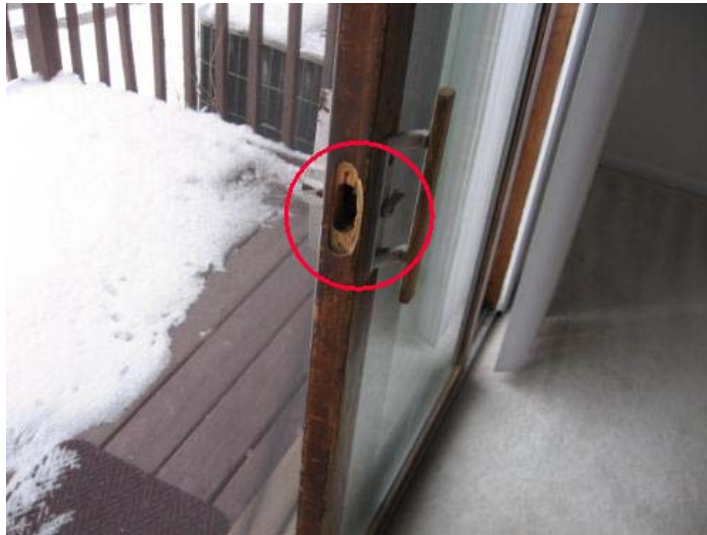
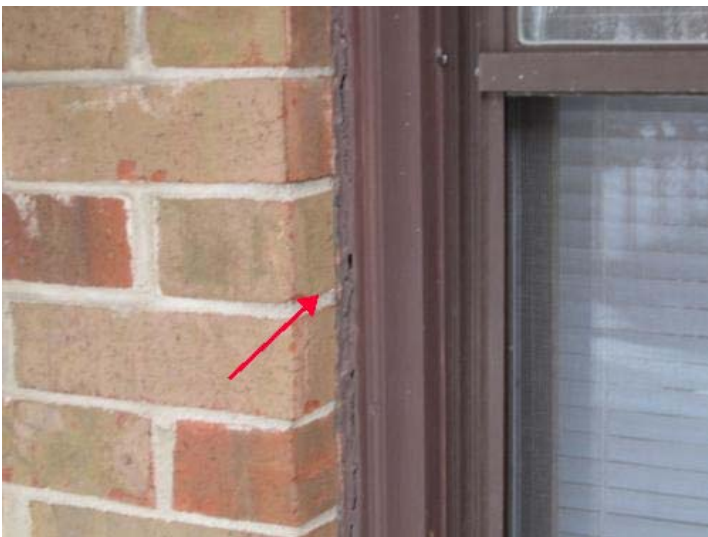
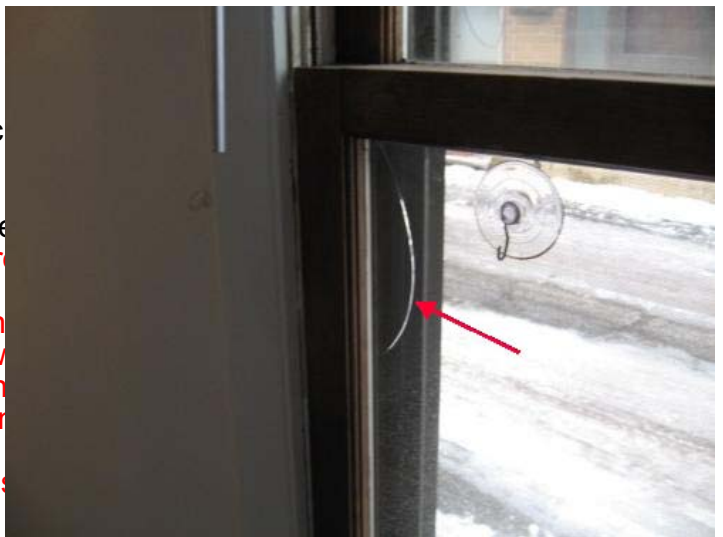
Type: Metal entry doors • Rear sliding door  
 Observations: **Sliding door does not operate smoothly on track, adjustment/repair needed.**  
**Sliding screen door does not operate smoothly on track, adjustment/repair needed.**  
**Sliding door has fogged glass between panes indicative of a thermal seal break.**

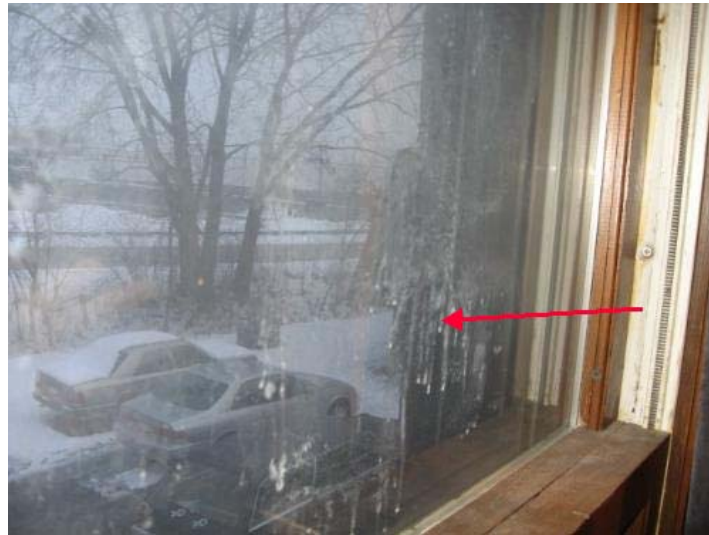
Fogging btwn window panes, thermal seal break suspected

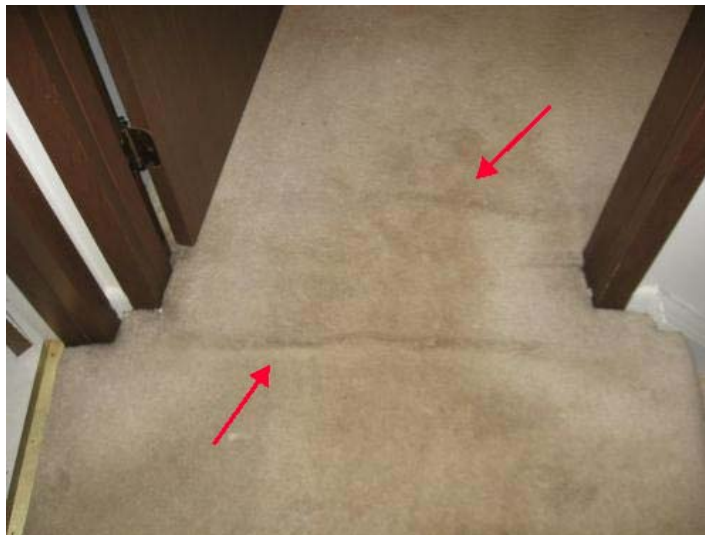
Materials: Drywall ceiling • Tiled floors • Carpeted floors  
 Observations: **Basement "peel and stick" tiles are loose.**  
**Carpeting is buckled and in need of stretching.**

buckling carpet on 2nd flr, trip hazard

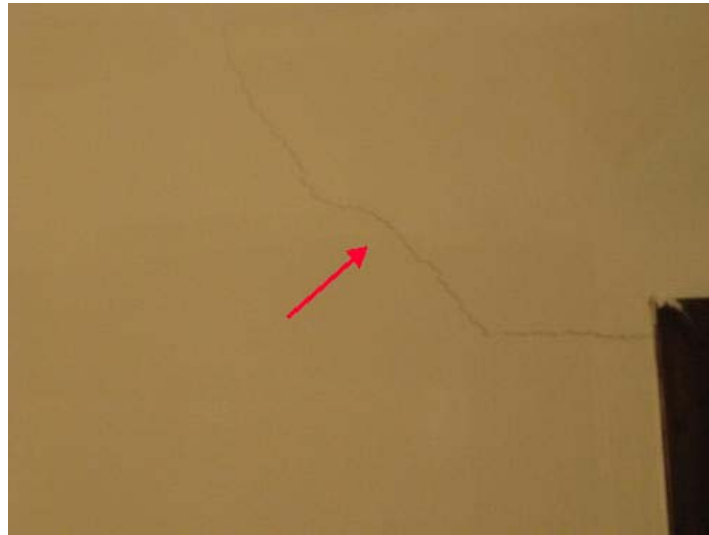
Materials: Drywall  
 Observations: SE bedroom west wall has cosmetic wall crack over doorway

Drywall crack SE bedroom

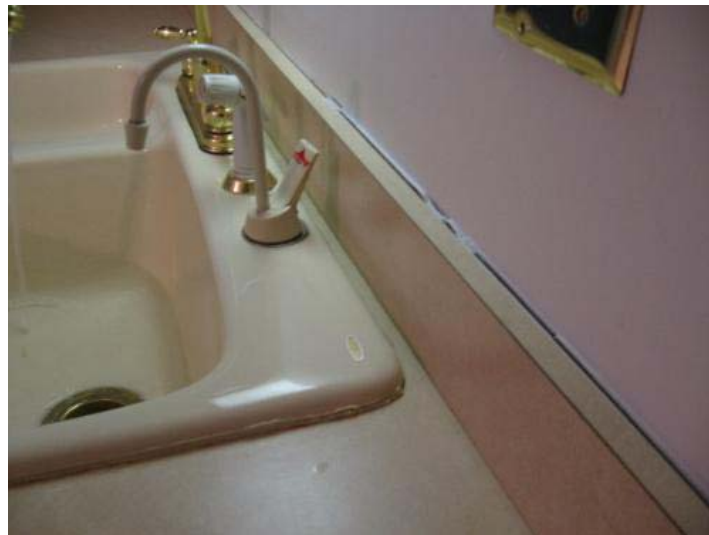
Materials: Wood cabinets, Laminate counters  
Observations: **Caulk backsplash of counter at wall to prevent water penetration.  
Bowing noted at sink cabinet base from water damage.**

Caulk counter backsplash

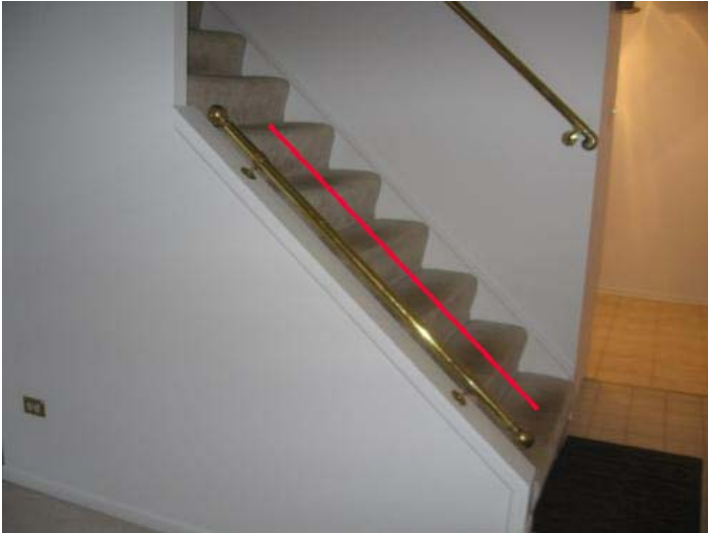
Improper handrail

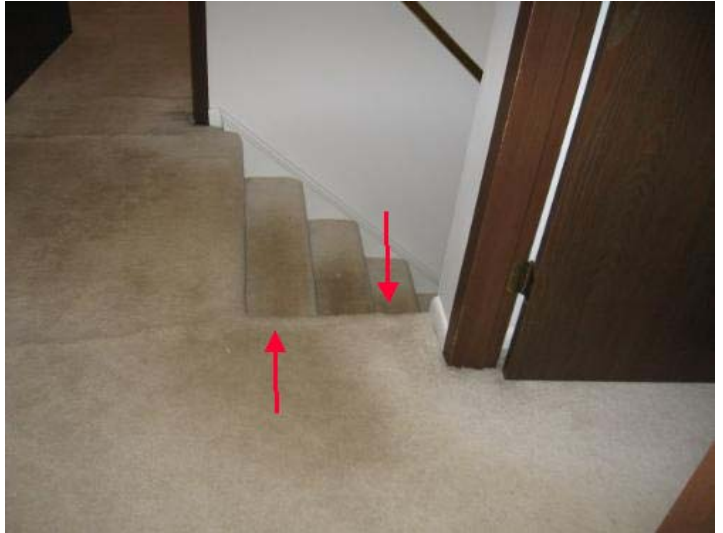
Observations: **Safety rails needed at top of stair at 2nd flr. • Improper rails noted at stairway.**

Safety rail omitted on 2nd flr

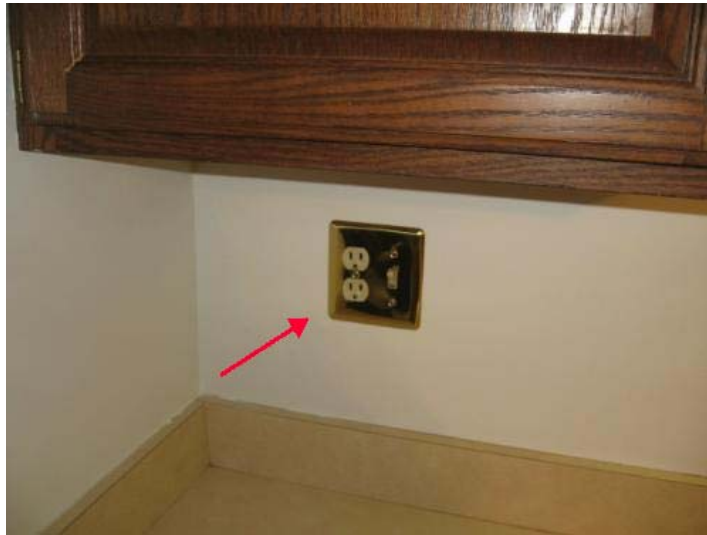
Observations: GFCI outlets needed within 6 ft of any water source  
 GFCI needed over kitchen counter to left of sink.  
 GFCI in first floor 1/2 bath would not trip when a fault was simulated.  
 Outlet in basement north wall has an open ground and loose on wall.

GFCI outlet needed over counter in kitchen

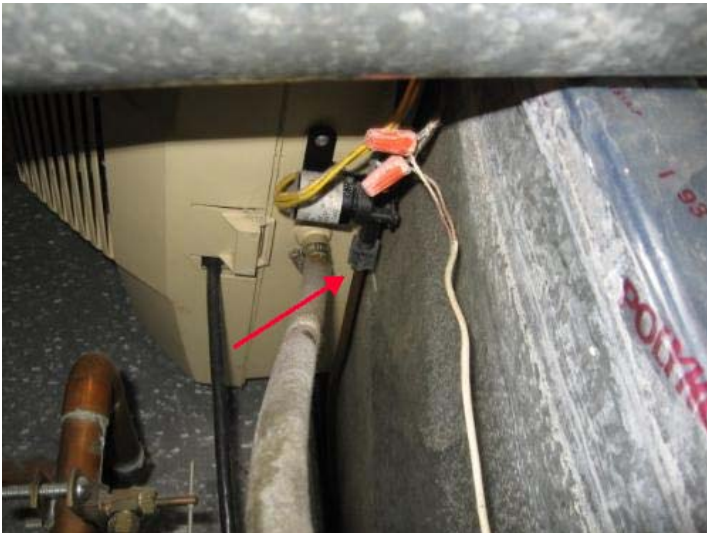
Installed humidifier leaks when turned on.

Humidifier leak noted

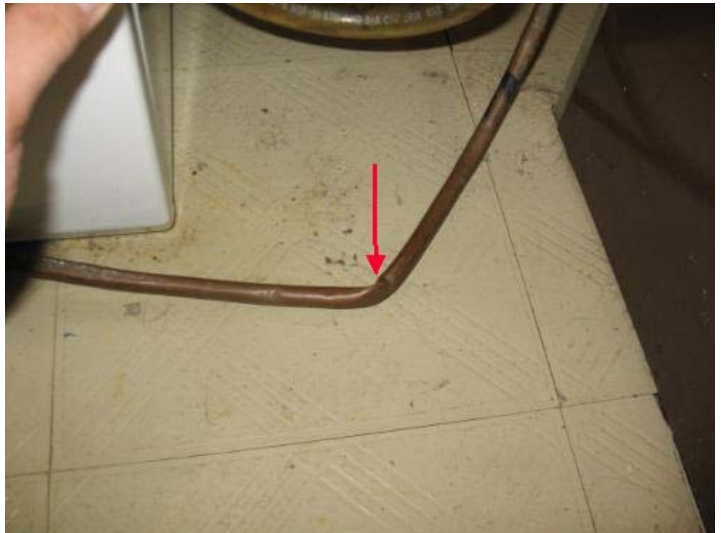
Humidifier drain kinked

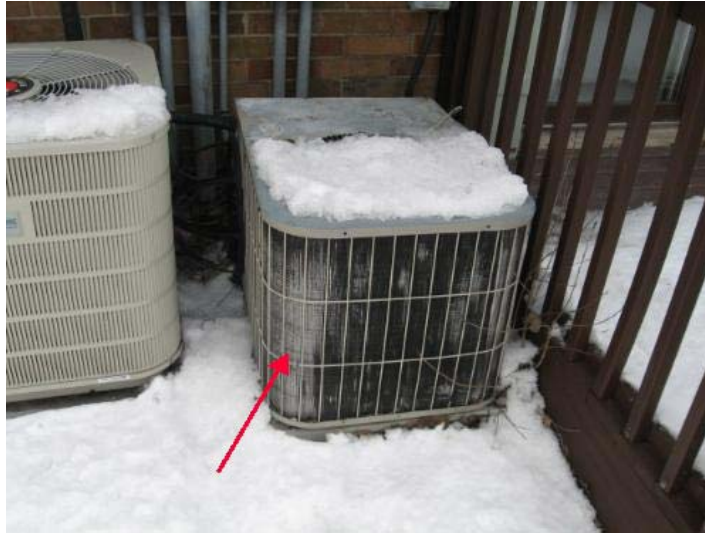
A/C condenser fins are bent, "combing needed"; consult an HVAC tech.

View of AC condenser, bent fins noted

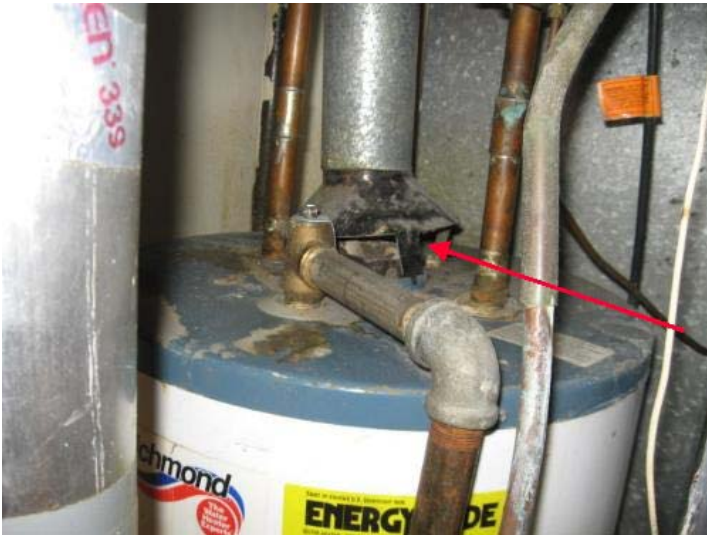
Draft vent askew

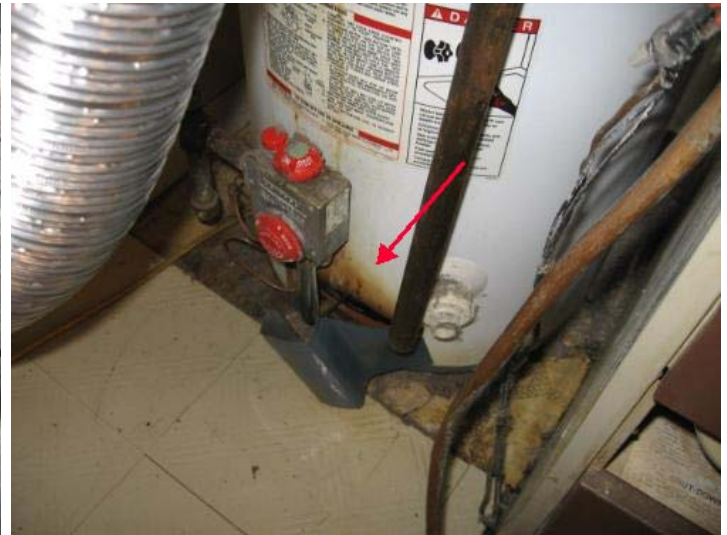
Burn marks noted on water heater cabinet, indictaive of flame roll out.  
 Water heater draft hood is askew, proper installation needed.

Evidence of flame rollout

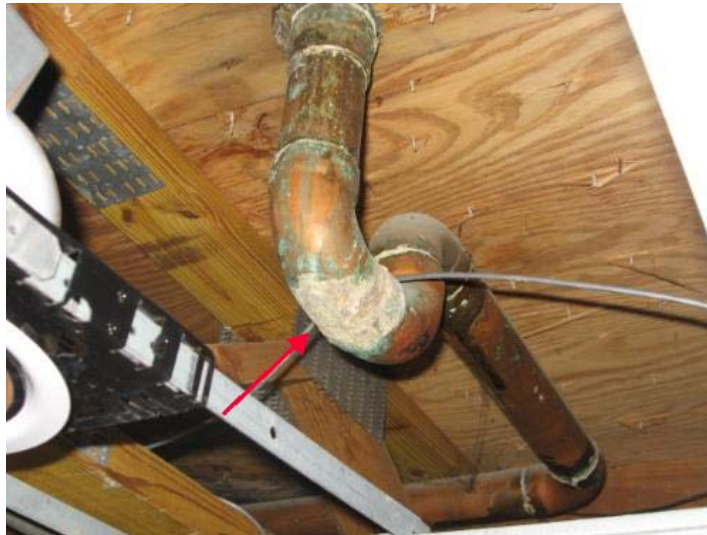
Observations: First flr 1/2 bath vanity is slow to drain, rodding may be needed.  
 Corrosion noted on drain line, visible from basement area, monitor for potential leaks.

Corrosion on drain line (basement view)

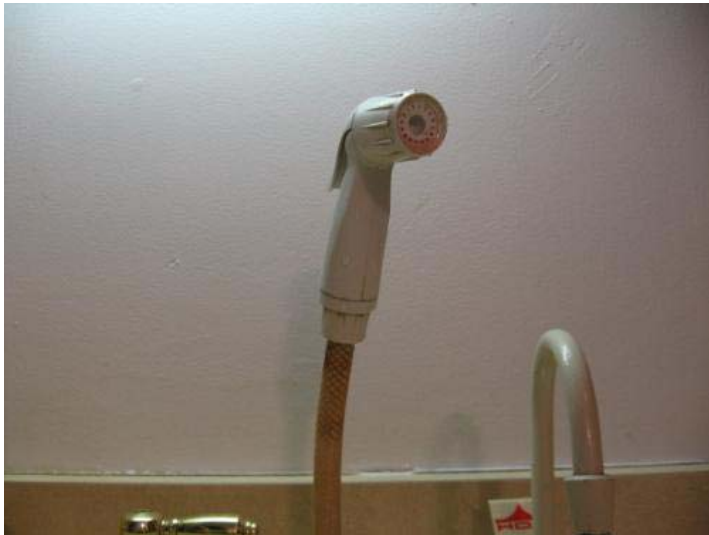
Kitchen sink faucet sprayer handle leaks when water source is active.

Kitchen spray diverter has active leak

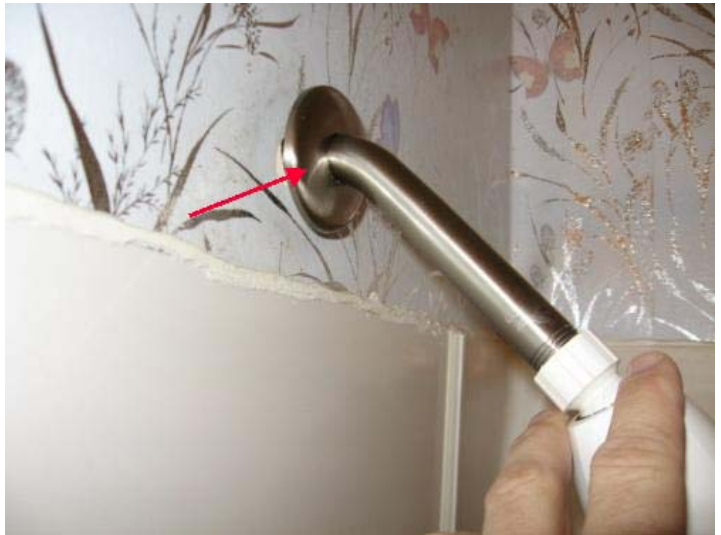
Shower supply pipe is loose at wall intersect in 2nd flr bath.

Shower pipe loose at wall intersect, 2nd flr bath

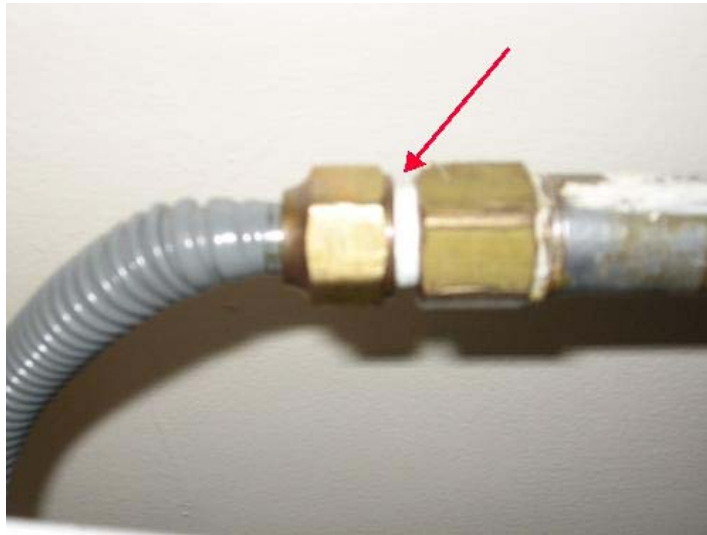
Non gas rated teflon use suspected on dryer

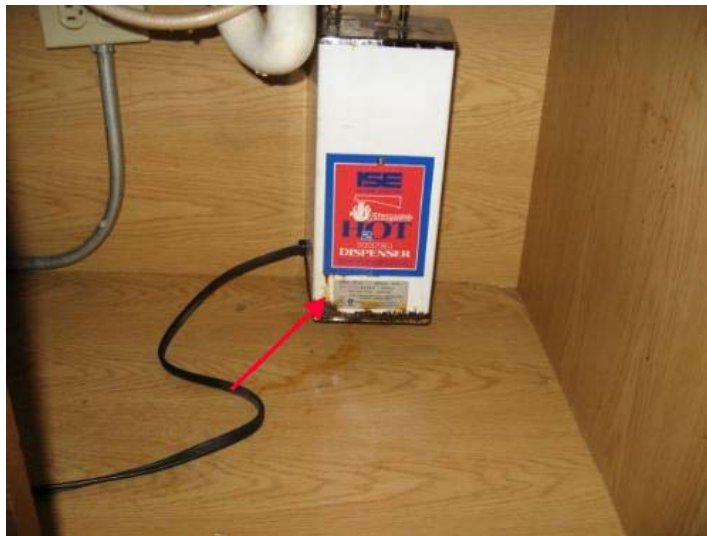
Observations: Hot shot water dispenser under sink not functional, rusted casing

Hot shot water heater not functional

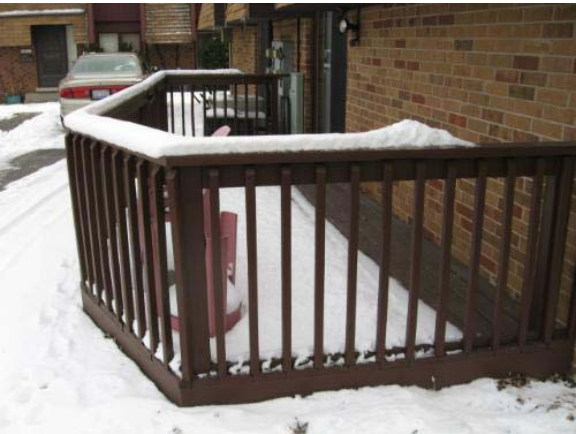
Materials: Wood deck • Concrete Stoop  
Location:  
Observations: Limited view of wood deck due to snow cover  
appears functional

Wood deck, snow covered
