ROCK-SOLID Inspections

Home Inspection Services

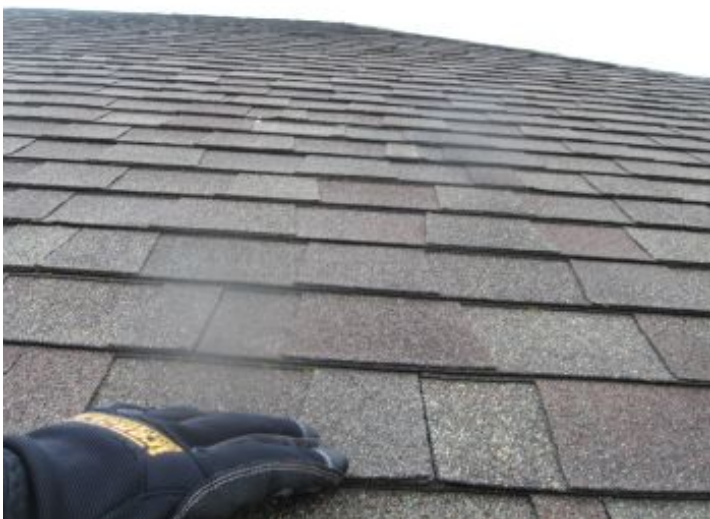
View of overall condition of roof (info only)

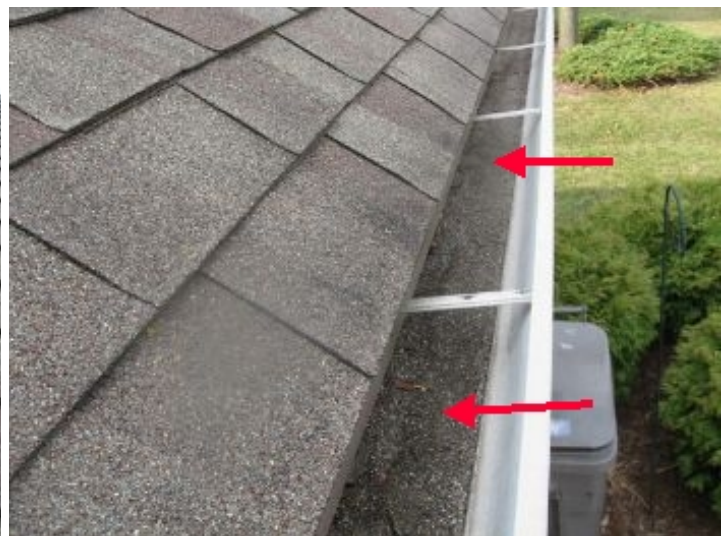
Evidence of shingle granule loss noted in gutters

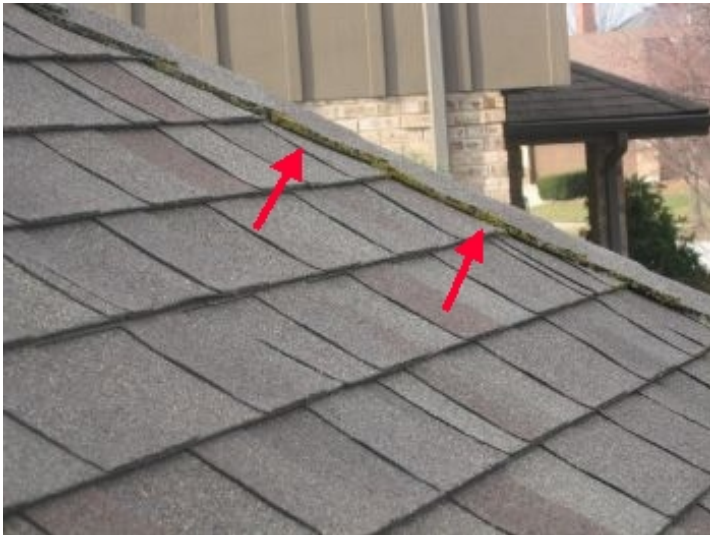
Minor moss build up noted on shingle edges

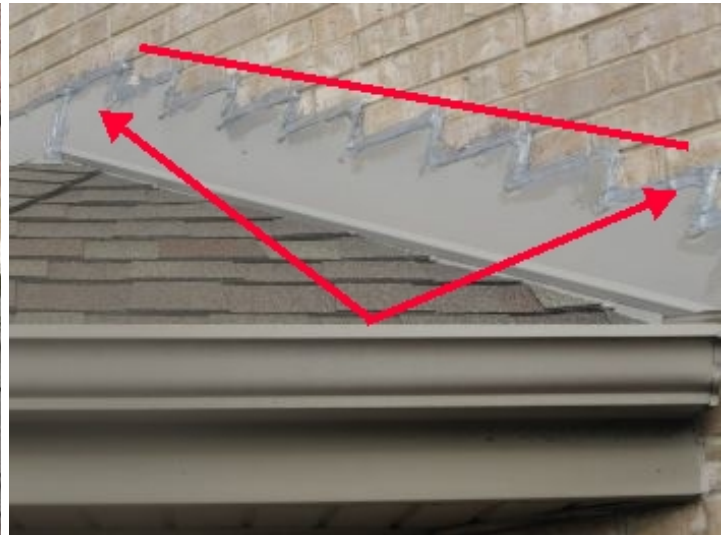
Evidence of recently applied caulking on rear flashing over kitchen dinette doorway; unk if new application was due to leaking or merely a maintenance precaution

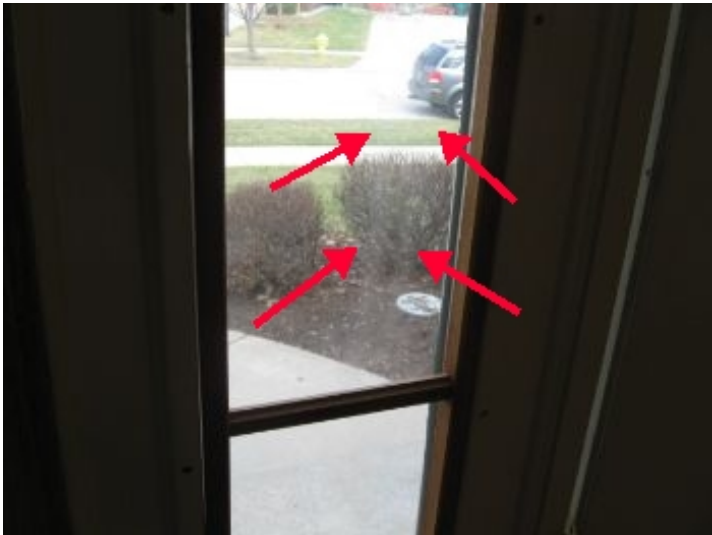
Front entry door side light to north has minor hazing between glass, may be indicative of a thermal seal break; monitor condition for further fogging, or moisture between panes

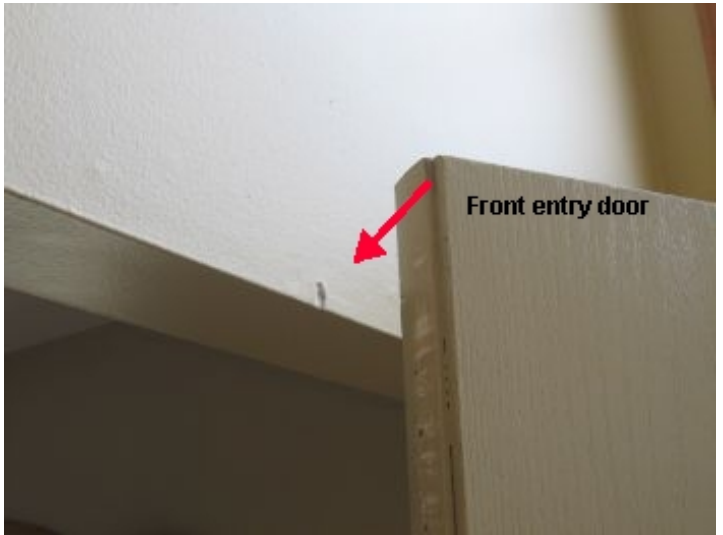
Front main entry door stoop needed, minor wall board damage noted from door

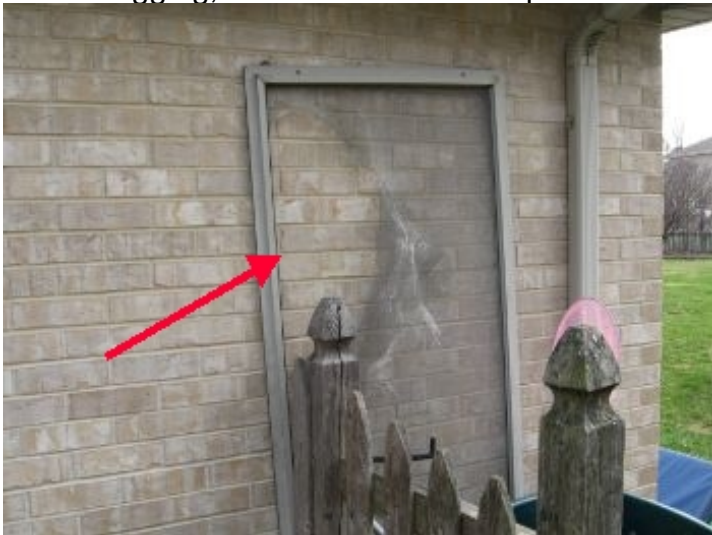
Rear sliding screen doors are removed, door frames are present outside both with torn screens; repair as needed, install and reevaluate

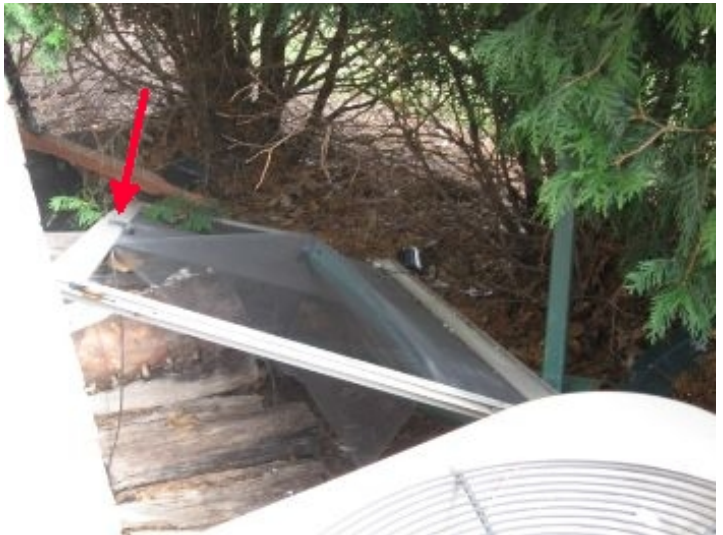
Rear sliding screen doors are removed, door frames are present outside both with torn screens; repair as needed, install and reevaluate

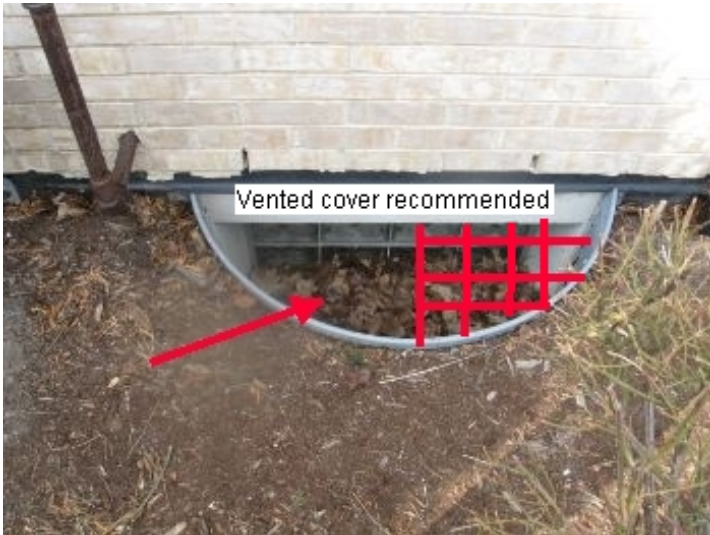
Basement window wells are full of leaves and debris, clean as needed : Well covers recommended

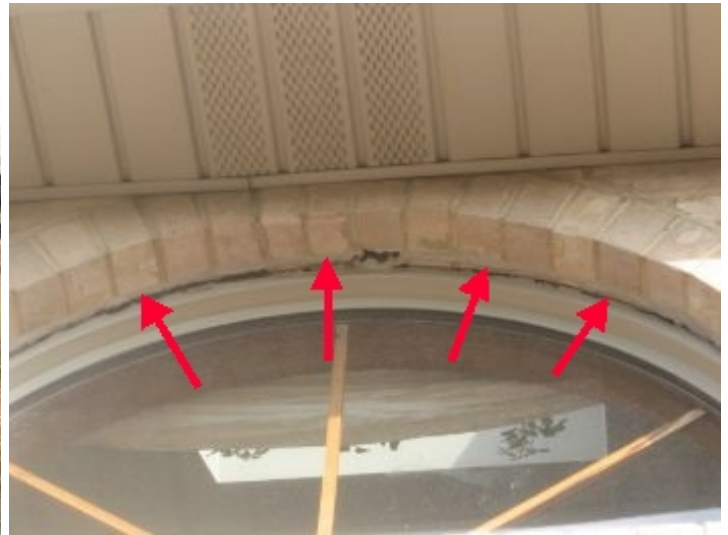
Exterior stationary arch window on upstairs bath has deteriorated caulk, new application needed

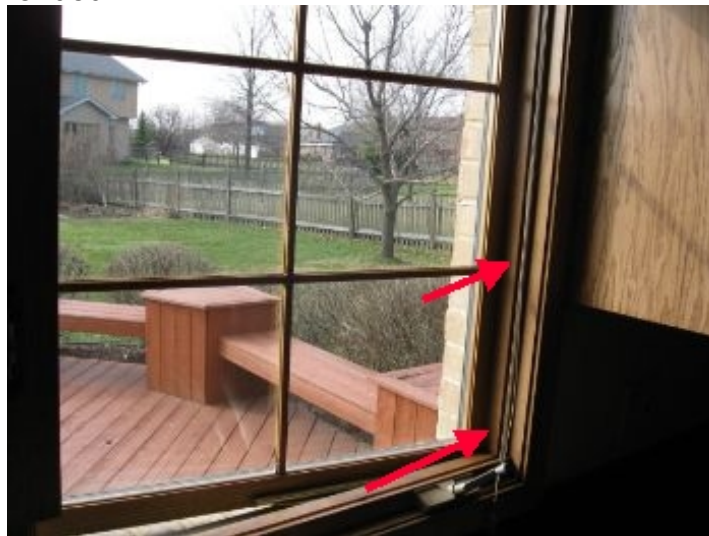
Kitchen window over the sink does not open completely, window sash hits style; adjust/repair as needed

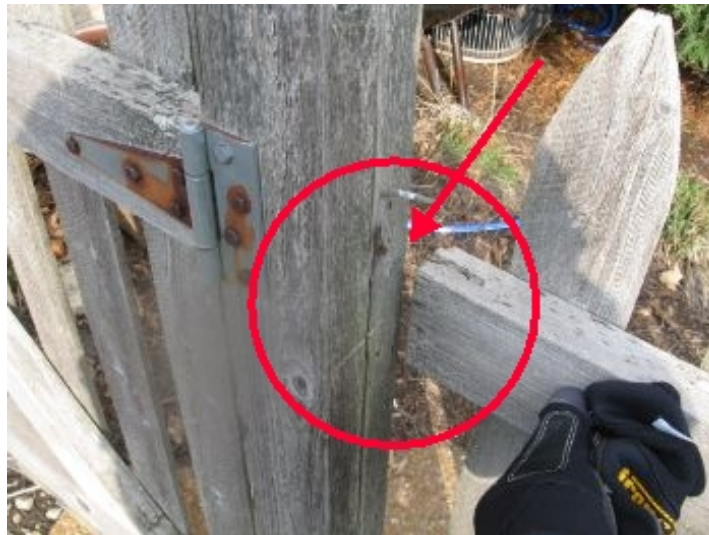
Wood fence is weathered with areas of loose fencing and sagging fence posts; repair as needed

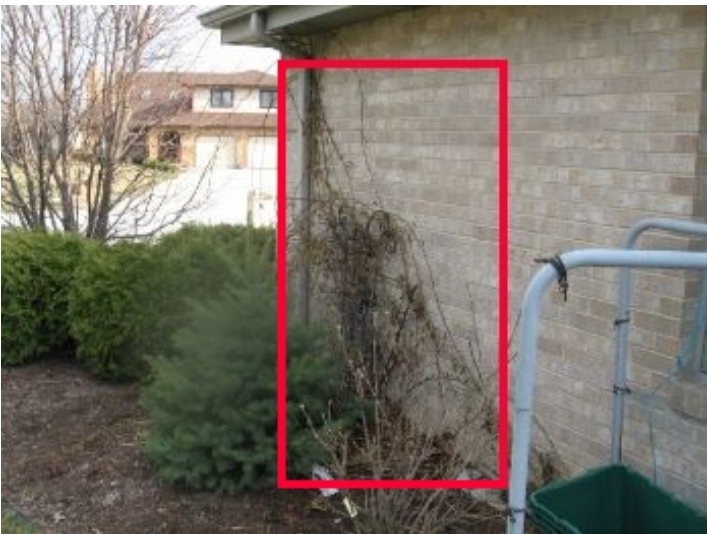
Shrubs should be trimmed back 18-24 inched from the house, to prevent excessive moisture against house and deter insect infestation

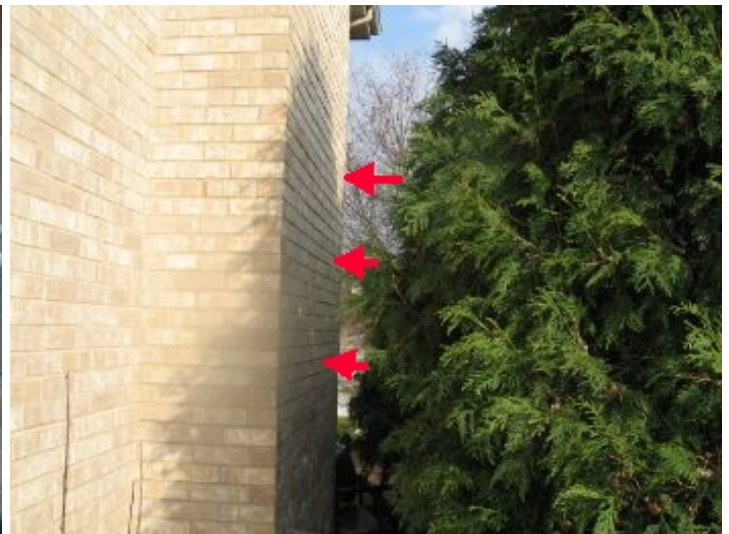
Shrubs should be trimmed back 18-24 inched from the house, to prevent excessive moisture against house and deter insect infestation

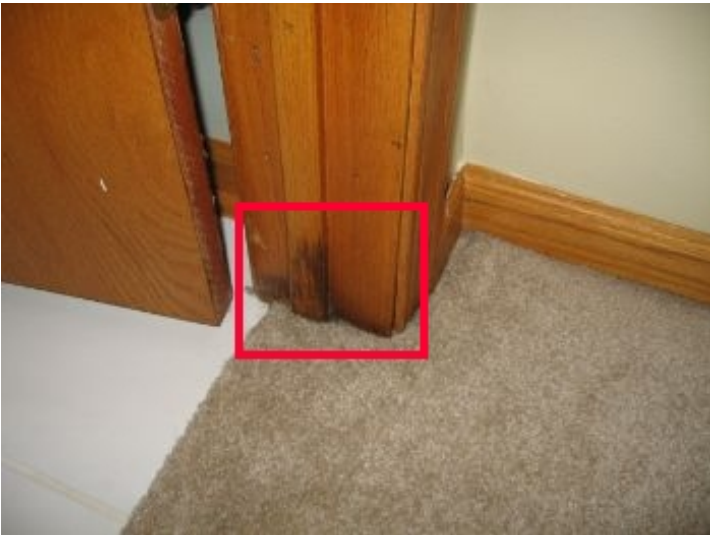
Evidence of water damage on interior door jamb of basement bathroom door; undetermined source of penetration; no other evidence of water stains or penetration noted; monitor area for any signs of water penetration

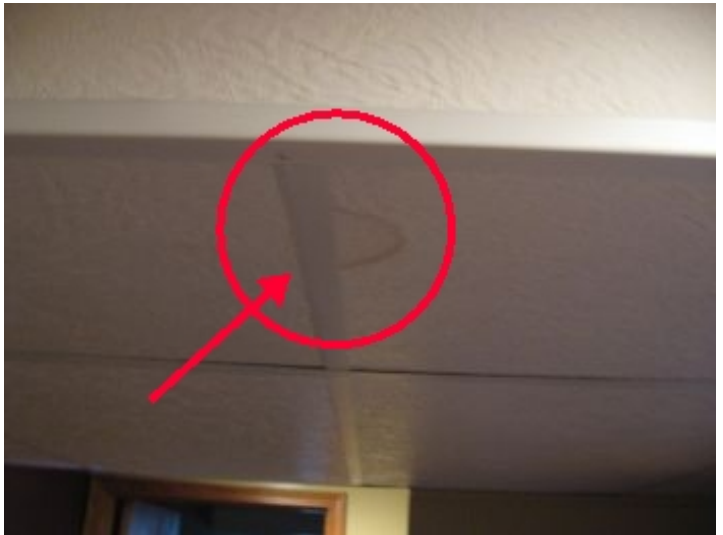
Small area of water stains noted on drop ceiling tiles, further inspection revealed the main water supply line overhead; no leak detected stains may be result of pipe sweating during periods of high humidity. Recommend application of pipe insulation to prevent sweating.

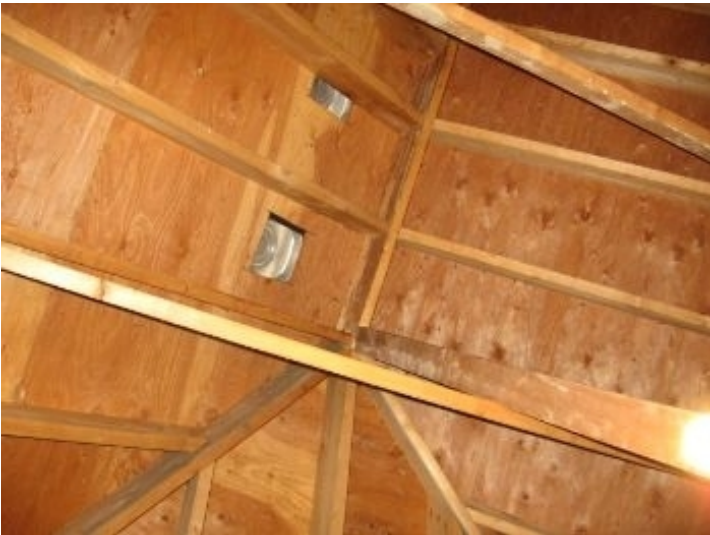
View of upper roof structure (info only)

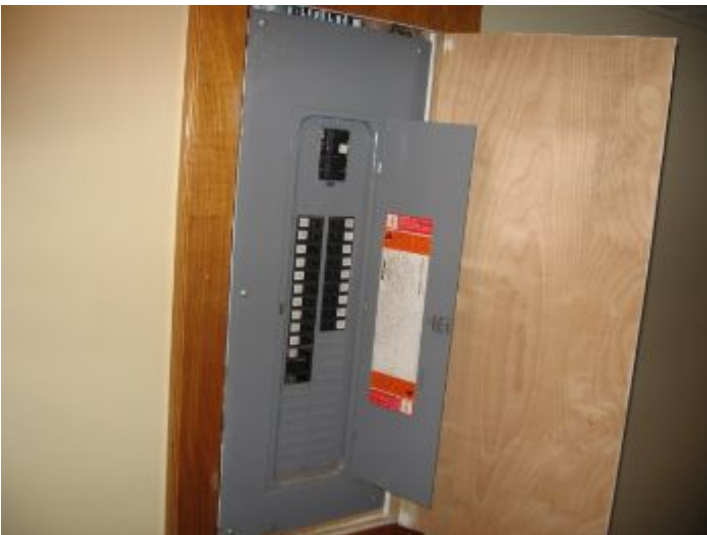
View of 200 amp panel (info only)

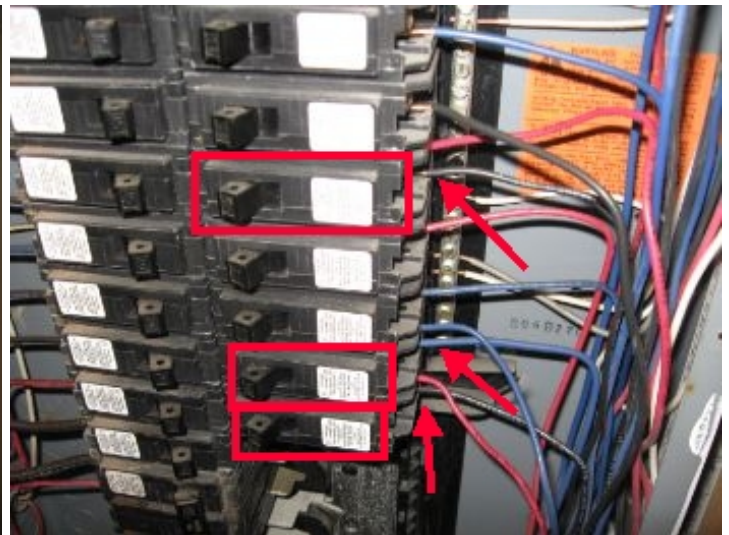
Three (3) double tapped breakers noted in panel ( two circuits run from a single pole breaker); consult a licensed electrician for evaluation and repair.

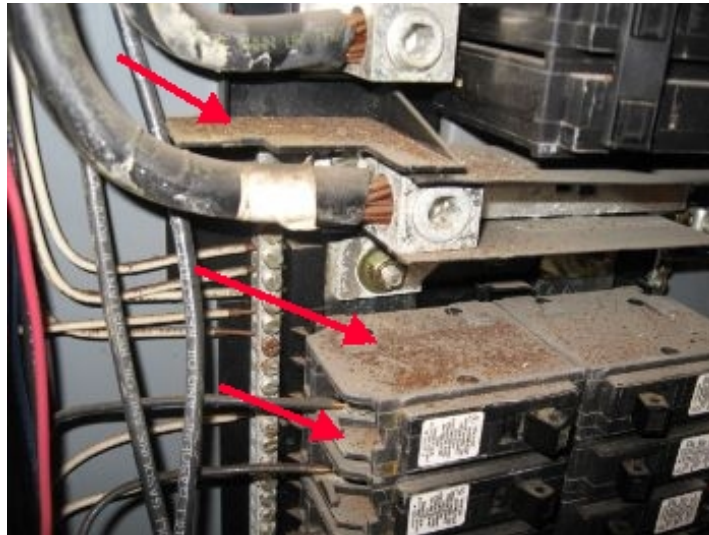
Excessive amount of debris noted in panel, UNK area on entry; accumulation on breakers or wires may result in corrosion or failure of breaker operation

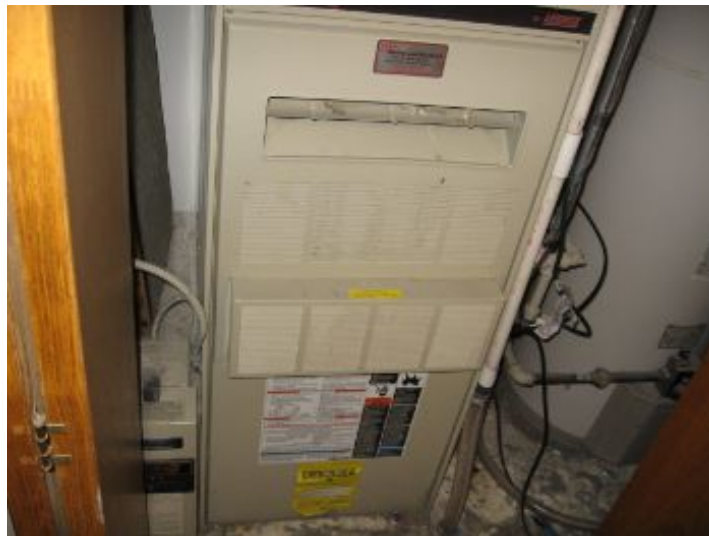
View of furnace (info only)

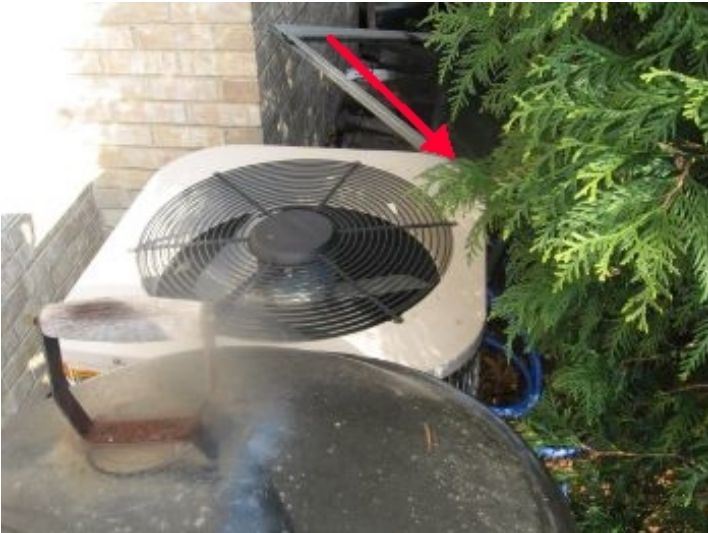
Large shrub in close proximity to condensing unit; this will restrict air flow to unit which reduces efficiency of unit and may reduce life expectancy of unit

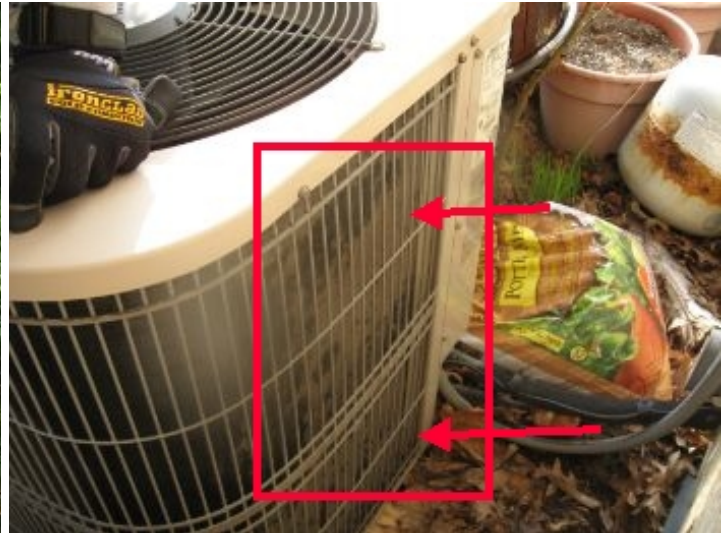
Debris build up noted on air conditioner condenser fins on exterior unit; clean as needed to ensure proper operation

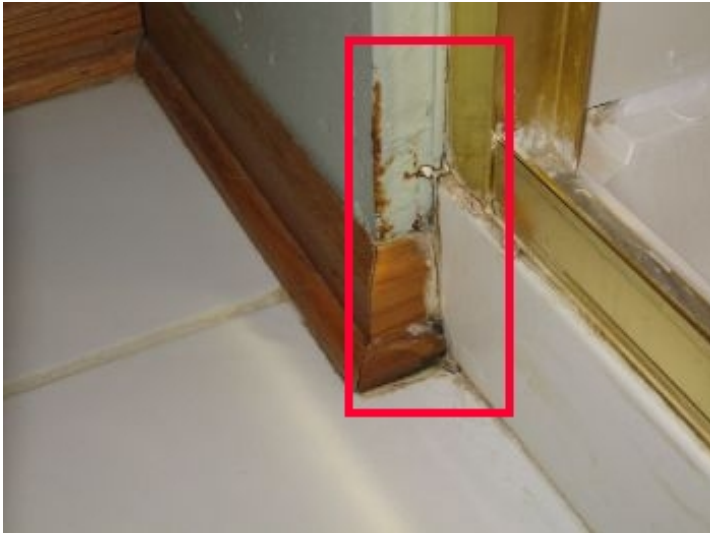
Basement bath shower base perimeter has areas of water penetration beyond shower walls and doors; may be result of deficient caulk application

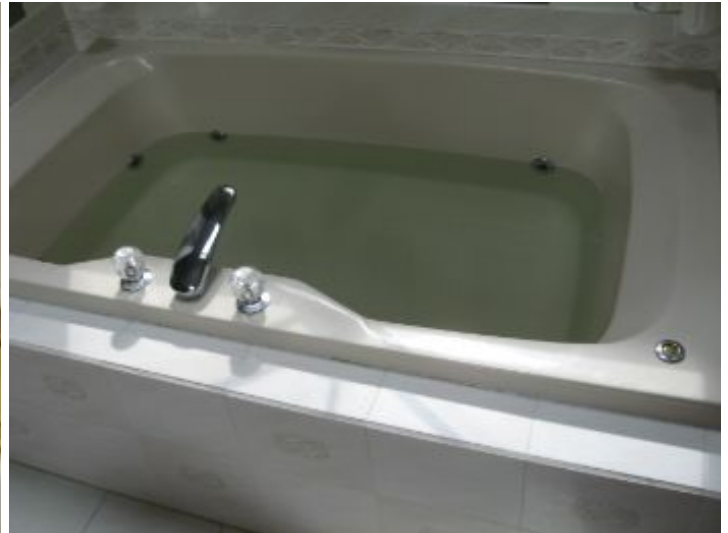
Jacuzzi tub, jets not functional, drain slow

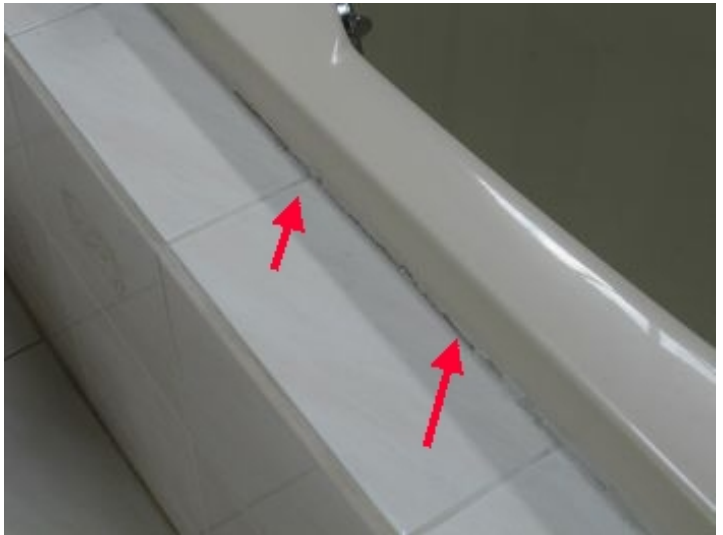
Deteriorated caulk noted on jacuzzi tub perimeter, new application recommended to prevent water seepage

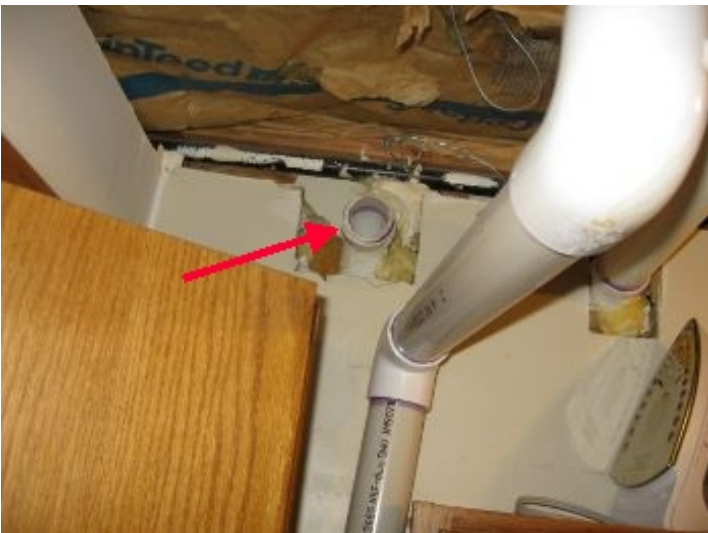
Ejector discharge line has improper short 90 degree joints installed; all 90 degree joints should be longer sweeping joints to ensure against clogging and ensure functional water flow. Consult a licensed plumber for evaluation

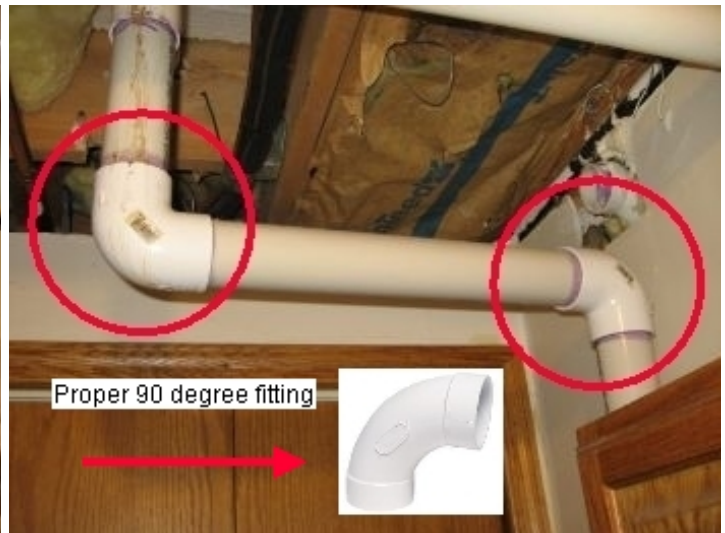
Ejector discharge line has improper short 90 degree joints installed; all 90 degree joints should be longer sweeping joints to ensure against clogging and ensure functional water flow. Consult a licensed plumber for evaluation

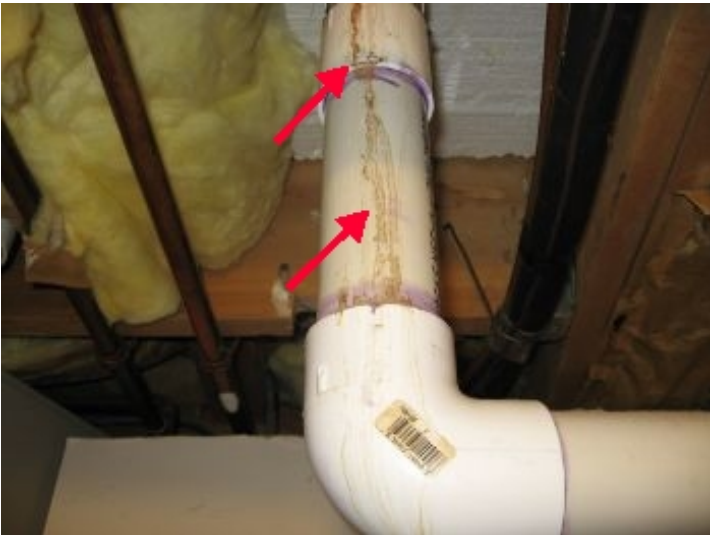
Water stains noted on ejector discharge lines, no leakage observed, monitor affected areas for leakage

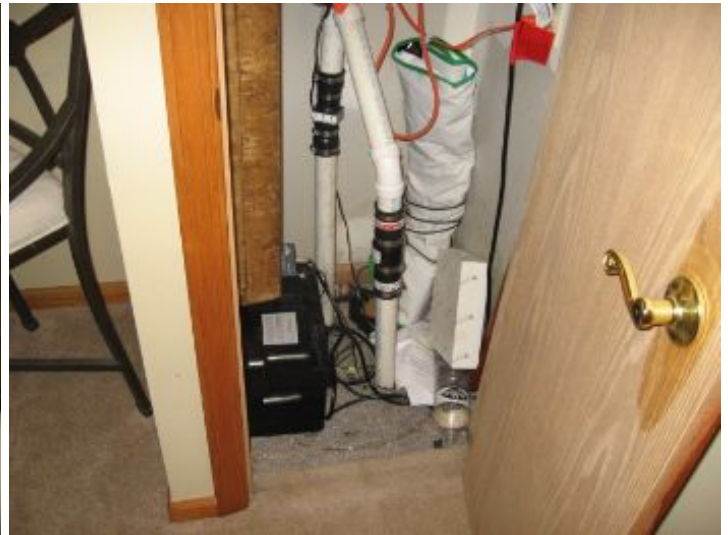
View of sump w/ battery back up (info only)

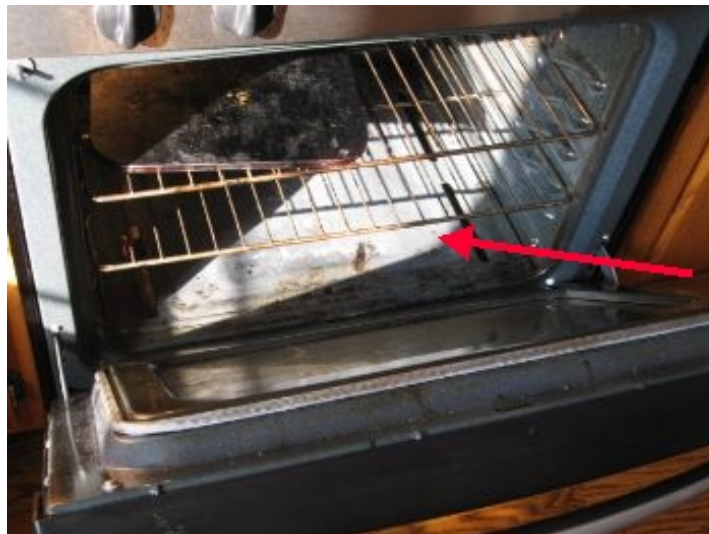
Grease build up noted in oven, clean as needed to avoid grease fire
